Non-Intrusive Diagnostics of Outdoor Ceramic Insulators Using Ultrasonic Signatures and Deep Learning Models

A thesis

presented to the University of Waterloo

Electrical and Computer Engineering

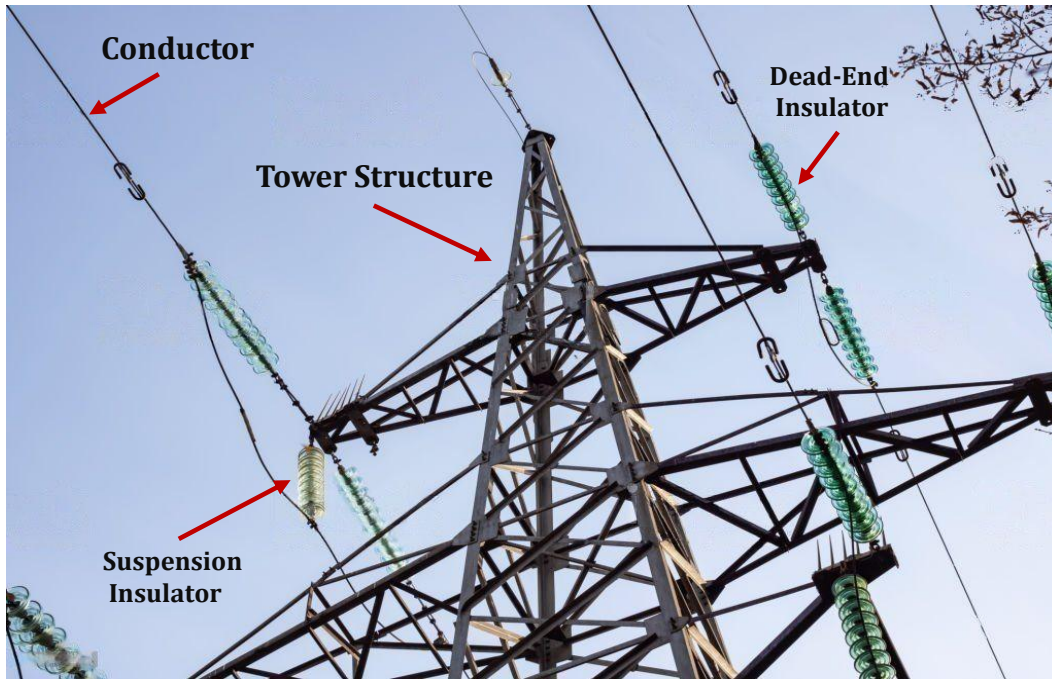
Overhead transmission systems generally consist of three primary components: conductors, insulators, and tower structures. The tower structure and insulator design vary based on the system's voltage level. Figure 1.1 illustrates the design of a high-voltage transmission tower in the 132–220 kV range. Insulators provide mechanical support to high-voltage conductors while electrically insulating them from the grounded tower structure. Two primary types of insulators are currently used in the industry: ceramic (porcelain and glass) and non-ceramic polymeric insulators (such as EPDM, epoxy, and silicone rubber). Although ceramic insulators have been gradually replaced by polymeric ones over the past few decades, they remain in use in modern electric grids. Among ceramic insulators, glass types are preferred by many utilities because their visual inspection leaves no ambiguity, as they either remain intact or shatter completely. The following sections offer an overview of both types and compare their key characteristics.

Figure 1.1. Components of an overhead transmission system [8]

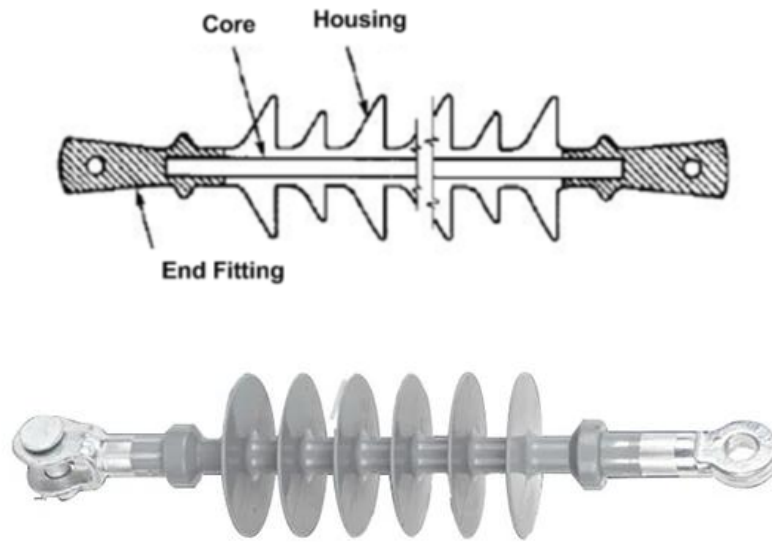
Figure 1.2 Composite Insulator Sample [9]

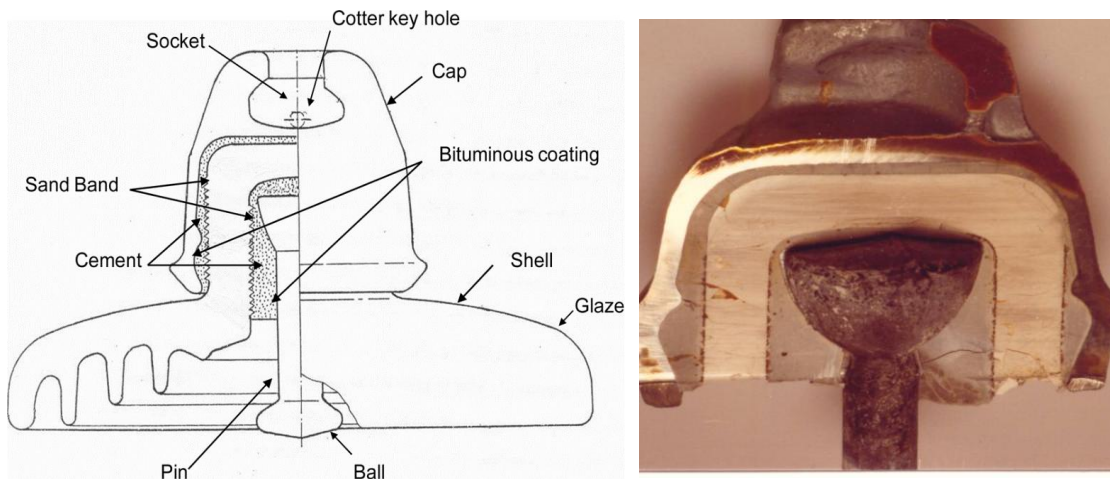
Ceramic insulators, introduced in the early 1900s, have undergone multiple developments in shell profiles and hardware designs. They consist mainly of a porcelain-fired dielectric shell, coated with a glaze that seals the surface and enhances its mechanical strength. Galvanized metal end fittings—often with flexible bituminous coating—from the cap and pin, which allow the insulator to bear mechanical conductor loads. Cement is used to bond the dielectric shell to the metallic hardware. Figure 1.3 shows a typical suspension-type porcelain insulator. Depending on the applied voltage and pollution severity, a series of ceramic discs is connected in string form, each disc potentially made from porcelain or glass.

Figure 1.3. Typical design of porcelain suspension insulator [2][9]

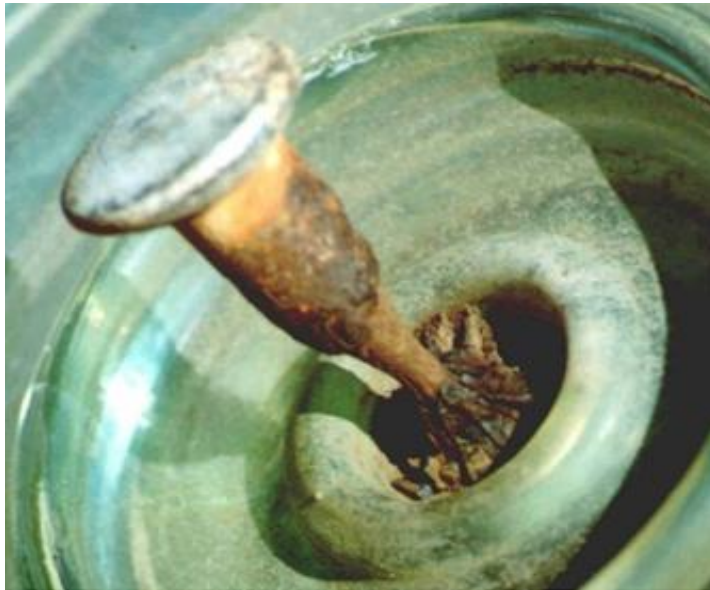
Pin corrosion commonly occurs in insulators exposed to high contamination levels and inadequate stress grading. At higher voltages, poor stress grading can initiate corona discharges, which gradually erode the protective galvanized layer and render the cap susceptible to corrosion. Additionally, inadequate galvanization and the absence of cathodic protection further accelerate pin degradation. When leakage currents flow on a wet, contaminated insulator surface, electrolytic corrosion can develop, substantially reducing the pin's cross-sectional area and mechanical strength, as shown in Figure 1.4. The rate of pin corrosion also varies between insulator types, with dead-end insulators experiencing higher exposure and faster deterioration compared to suspension insulators, where the pin remains more sheltered. Without timely intervention, this degradation may compromise the insulator's ability to support the conductor, potentially causing the conductor to drop.

Figure 1.4 Pin corrosion due to improper stress grading and high contamination [11]

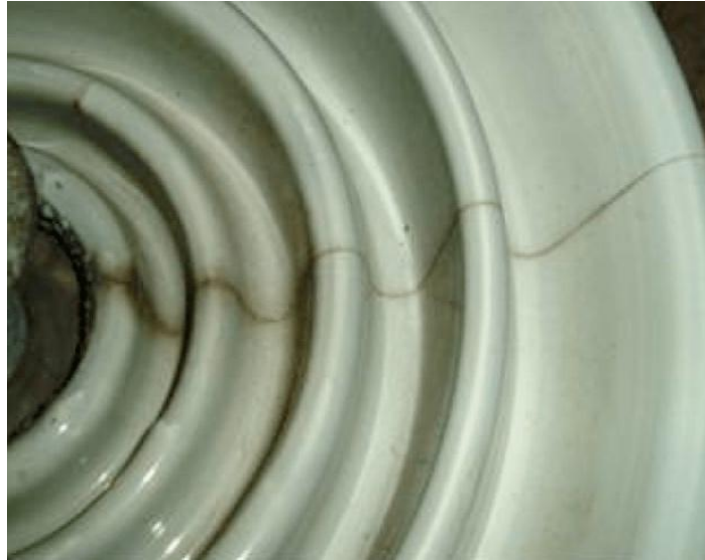
Portland cement is widely used in assembling porcelain suspension insulators. Field evidence indicates that over extended service periods, the dielectric shells of some porcelain insulators may develop radial cracking due to expansion of the Portland cement that binds the insulator structure. Ceramic insulators, being brittle, are particularly susceptible to cracking under the stress caused by the expanding cement. Moist atmospheric conditions—rain or high humidity—further accelerate cement expansion. Newer ceramic insulator designs integrate a bituminous layer to counteract cracking, but this layer deteriorates over time, causing uneven stress distribution that can lead to cracks in the dielectric shell. Figure 1.5 illustrates a radial crack resulting from the expansion of Portland cement, along with the gradual aging effects on the bituminous layer.

Figure 1.5 A radial crack in a ceramic insulator sample due to Portland cement expansion [12]

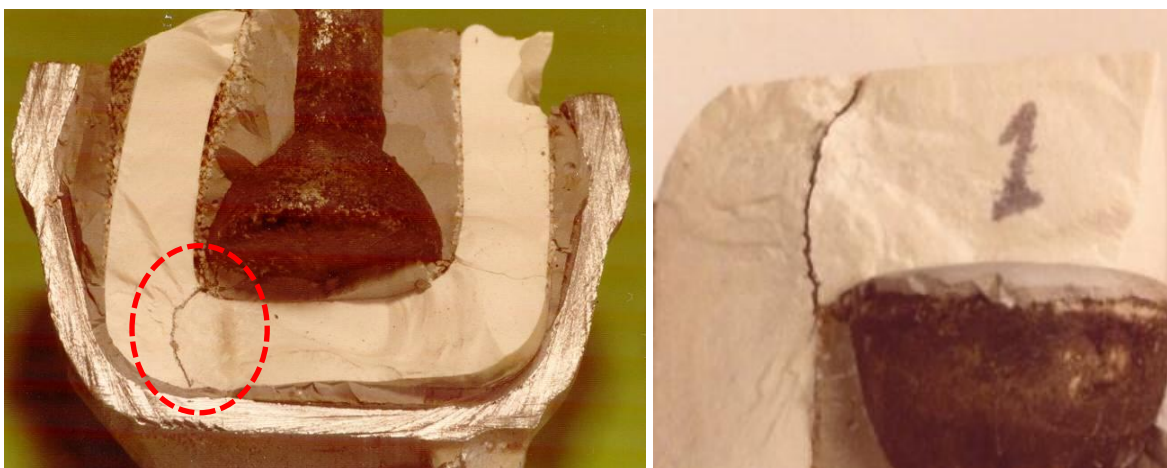
Figure 1.6 presents a cross-sectional view of a dissected ceramic insulator disc with a visible punctured pathway formed by a disruptive discharge. Such punctures not only result in a permanent reduction in insulation strength but also impose additional stress on neighboring insulators, accelerating their aging process.

Figure 1.6 Puncture of porcelain dielectric due to a disruptive discharge [9]

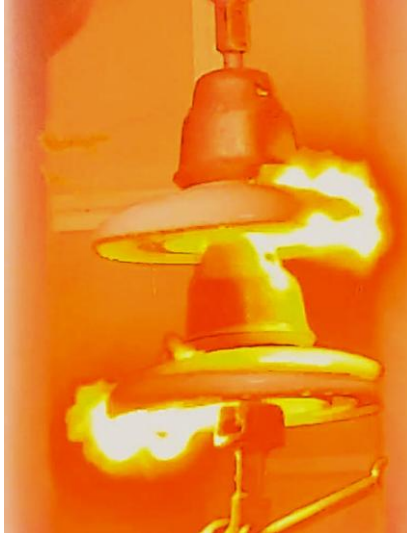
Figure 1.7 Insulator flashover due to wet contamination

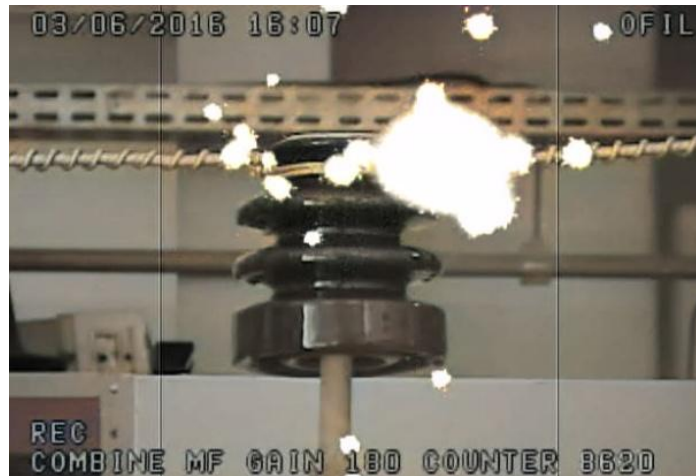
PD activity serves as a reliable early indicator of defective insulators. Cracked discs emit surface PD, which generates UV radiation within the 300-400 nm wavelength range—undetectable by the human eye or standard light-intensifying tools. Consequently, UV cameras, commonly known as corona cameras, are essential for detecting cracks in the dielectric shell. These cameras are also particularly effective in identifying hardware-related issues, such as corona discharges from protrusions and defective end fittings. Furthermore, they play a vital role in assessing contamination severity by visualizing DBA activity [20]. Figure 1.8 presents a UV measurement of a drilled, contaminated ceramic insulator. While corona cameras excel in detecting external discharges caused by cracks, wet contamination, or other surface defects, they are incapable of identifying internal defects that do not emit UV radiation to the surface.

Figure 1.8 UV camera measurement of a drilled contaminated insulator sample [21]

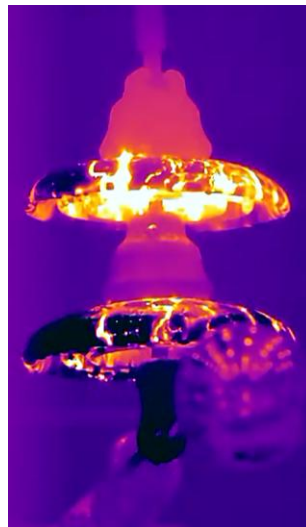
IR imaging is widely considered the standard technique for identifying defects linked to temperature rises, such as DBA. It is particularly adept at detecting joule heating caused by leakage currents on wet, contaminated insulator surfaces. Figure 1.9 illustrates DBA activity recorded via IR imaging on a string of wet, contaminated porcelain insulators in the High Voltage Engineering Laboratory (HVEL).

Figure 1.9 DBA on insulator string captured by IR camera

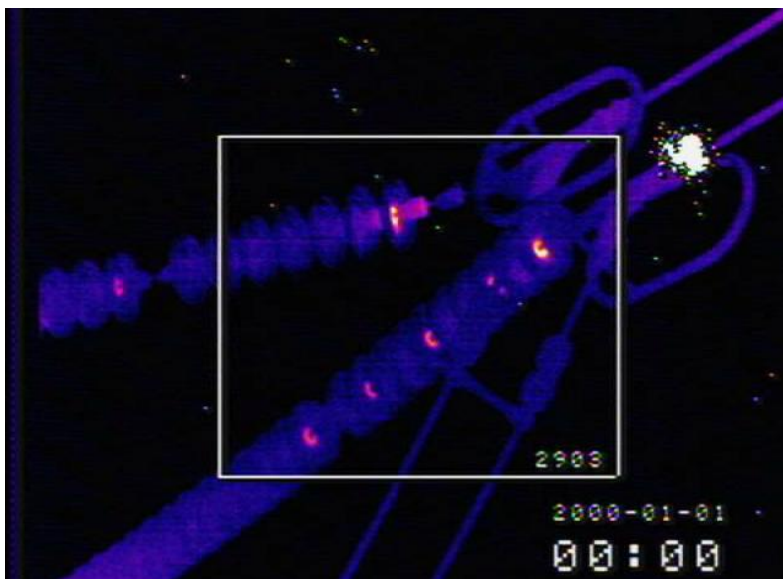
In some cases, IR imaging can detect PD in later stages or reveal insulator punctures associated with significant internal arcing. Nevertheless, IR is generally less reliable than UV imaging for identifying PD, as PD often generates less heat in its early stages. Consequently, IR and UV cameras are frequently used together in the field, providing a more comprehensive assessment. Figure 1.10 presents an overlapping IR and UV image showing multiple defects on the same insulator string [22]. The white spot corresponds to corona discharges from sharp points on the metallic hardware, while the orange spots indicate localized heating that may signal internal defects. The combined IR and UV data thus offer complementary diagnostic insights.

Figure 1.10 Overlapping IR and UV images of multiple defects on an insulator string [22]

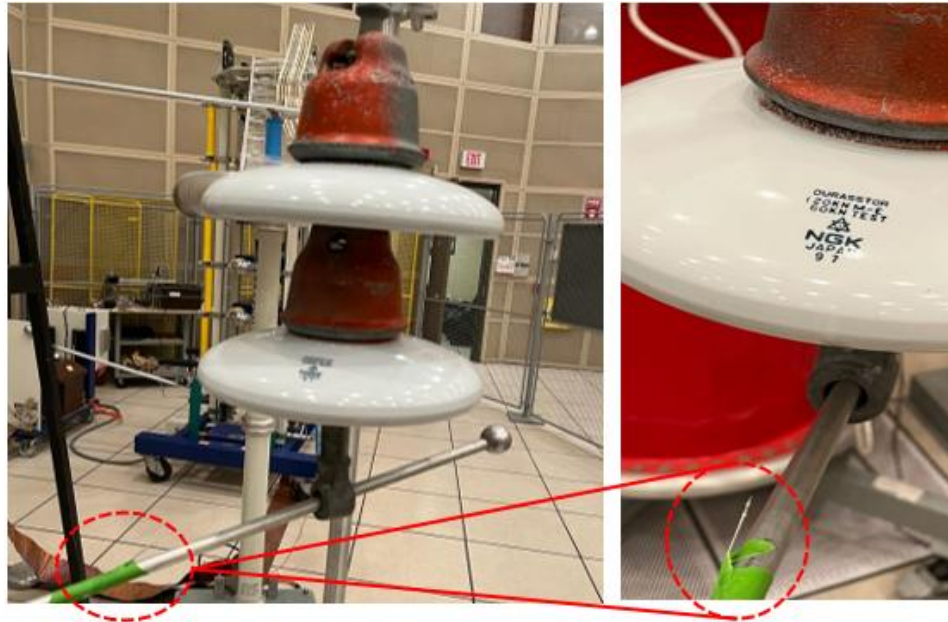
Figure 3.2 Hardware Corona generated by a sharp point attached near the HV end of the setup.

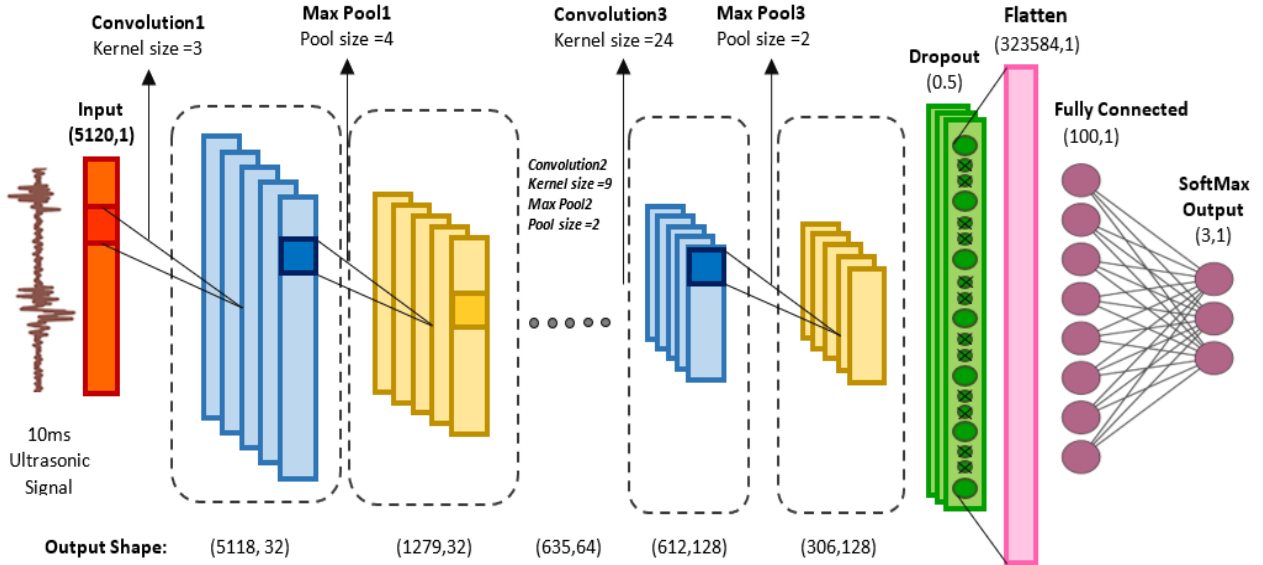
Figure 3.3 Proposed 1D-CNN Architecture

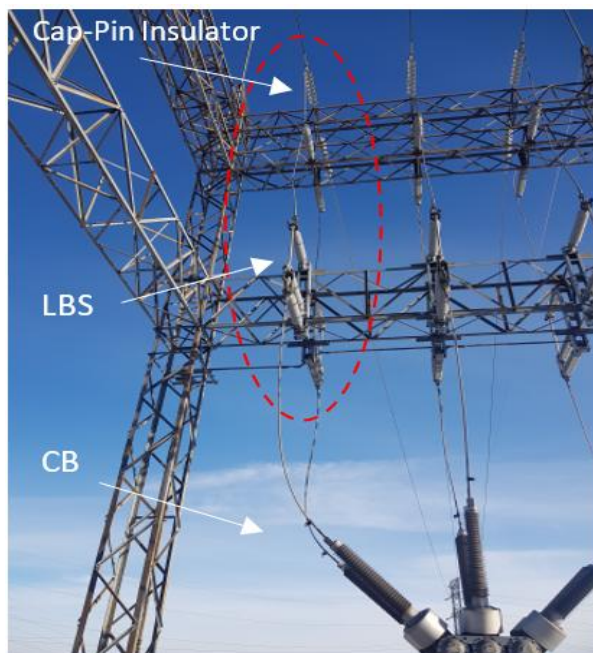
Figure 3.4 DBA observed on the ceramic insulator and LBS, highlighted by a red circle is a consequence of ice melting process.

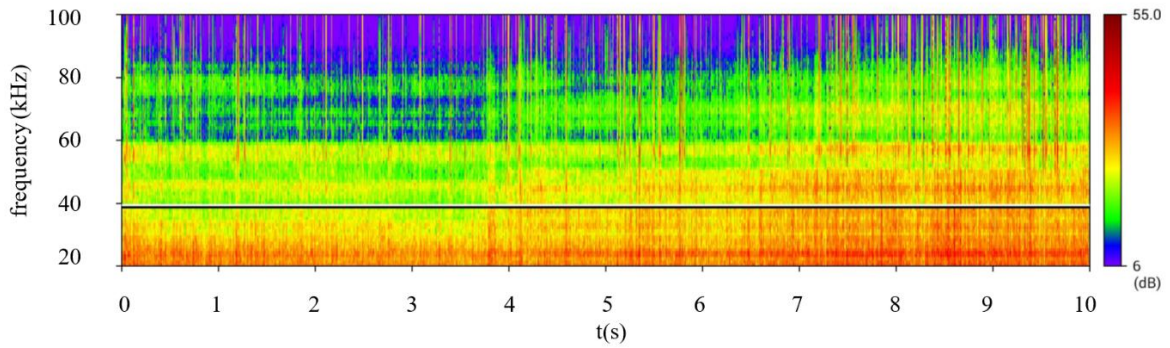
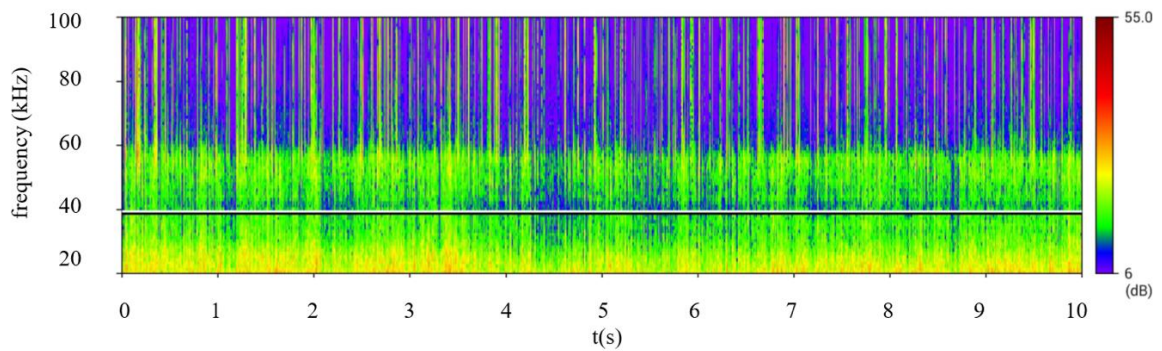
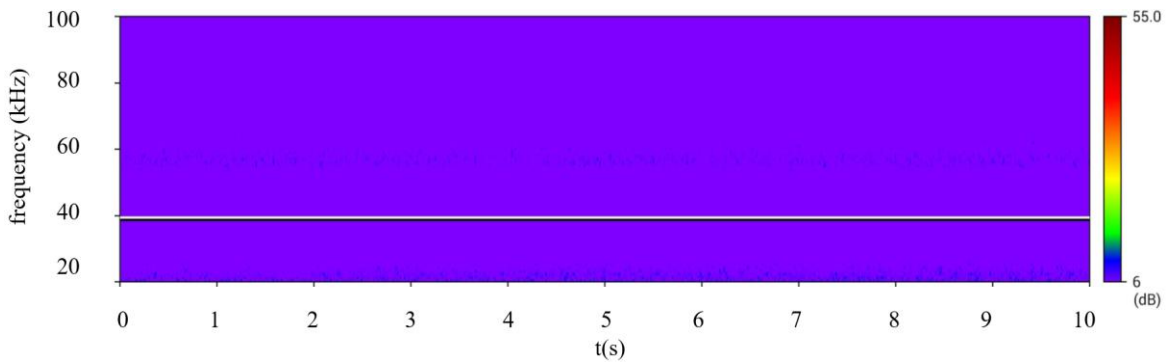
Figure 3.5. presents ultrasonic measurements recorded during and after the ice melting process on the insulator and LBS surfaces. After 2–3 hours, most ultrasonic emissions ceased, indicating the termination of DBA following the complete melting of the ice. Measurements were conducted at distances of approximately 15 m from the sensor to the LBS and 25 m to the insulator. The temporal reduction in ultrasonic emissions, closely correlated with the melting ice, further validates the model's capability to detect and distinguish between transient and persistent defects.

Figure 3.5 Ultrasonic measurements at different stages:

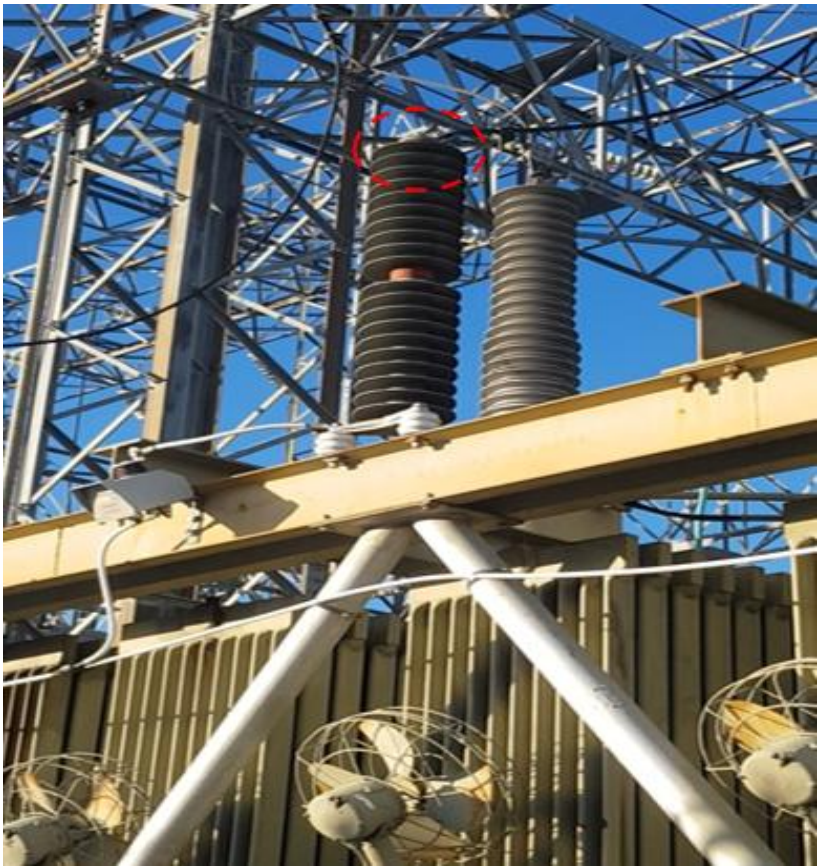
Figure 3.6 Loose connection on transformer surge arrester highlighted in red circle.

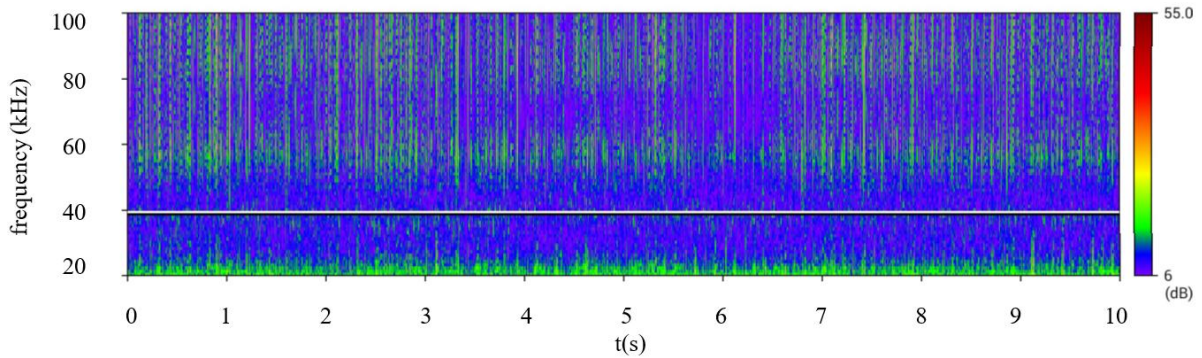
Figure 3.7 Ultrasonic measurement capturing Corona discharges arising from loose connection at transformer surge arrester

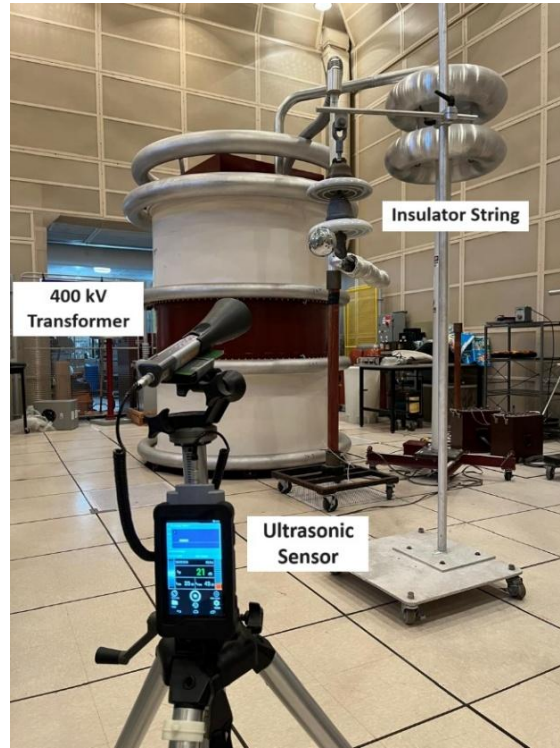
In this experiment, a 200 kVA, 400 kV test transformer was utilized to generate the high voltage required for testing porcelain insulators arranged in strings of two and three discs. The insulators were subjected to various defects, including wet contamination, internal punctures, and corona discharge, along with combinations of these defects. This resulted in a total of six distinct classes: three individual defects, their combinations, and a healthy (defect-free) class. The objective was to capture acoustic signatures corresponding to both individual defects and the interactions arising from multiple concurrent defects. These interactions often generate overlapping ultrasonic signals, which are crucial for developing precise diagnostic models. To facilitate this process, acoustic emissions were captured under controlled laboratory conditions using an ultrasonic sensor (Sonaphone BS30) placed 2 meters away, as described in section 3.1.1. The experimental setup is illustrated in Figure 3.8.

Figure 3.8 Laboratory experimental setup

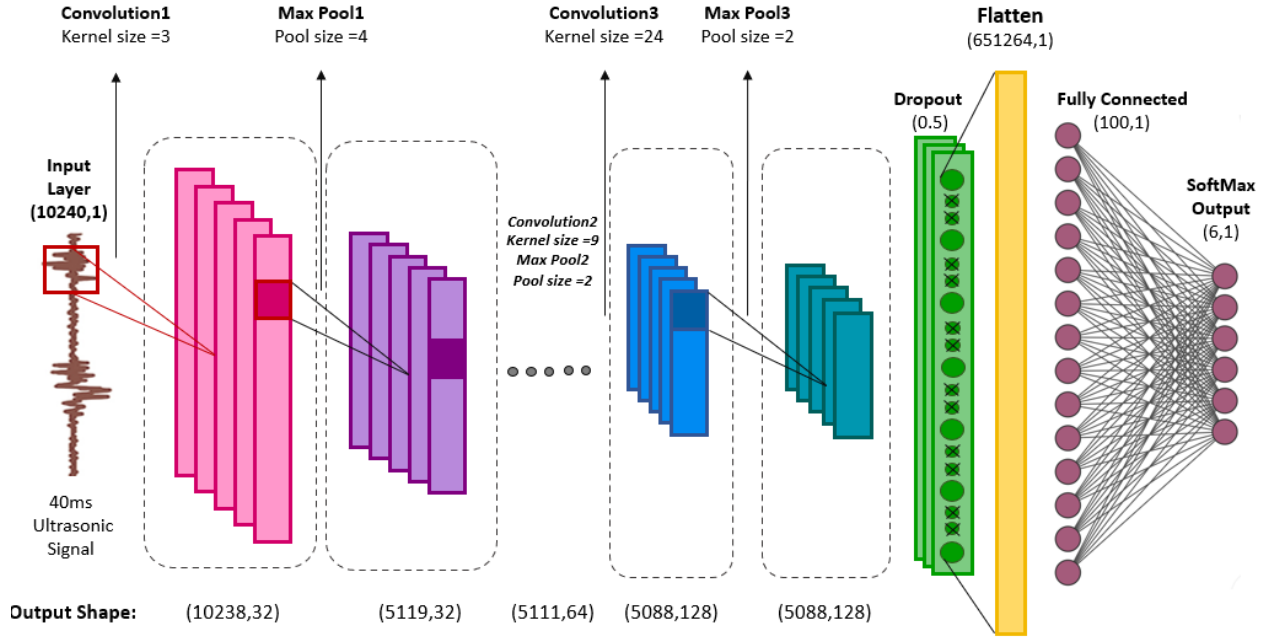
However, since this study considers only two defect combinations, the multiclass approach is more practical and appropriate. The multilabel approach, as noted earlier, could introduce physically invalid combinations, making it less suitable for this particular case. The proposed CNN model accommodates possible defect combinations by defining six distinct classes: healthy, punctured, DBA, corona, punctured with corona, and DBA with corona. The architecture of the CNN model is depicted in Figure 3.9.

Figure 3.9 Proposed 1D-CNN Architecture for overlapping defects

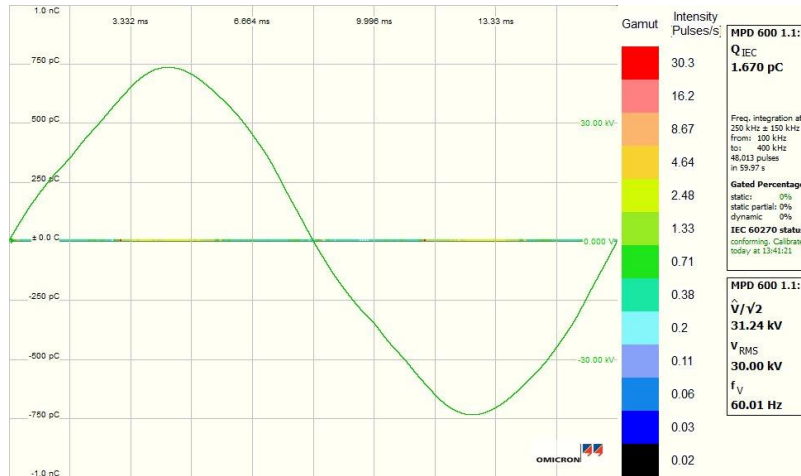
In this configuration, two healthy ceramic insulator discs (1 and 2) were arranged in a string and subjected to a voltage of 30 kV. The classical PD detector did not identify any signs of partial discharge activity on the insulators. However, minimal background noise, measured in picocoulombs, was detected, as shown in Figure 4.1. Furthermore, observations using the image intensifier and acoustic measurements confirmed the absence of surface discharge activity on the insulators, as illustrated in Figure 4.2. This scenario serves as a baseline for comparison with subsequent configurations.

Figure 4.1 1~2 pC of noise observed on the classical PD detector.

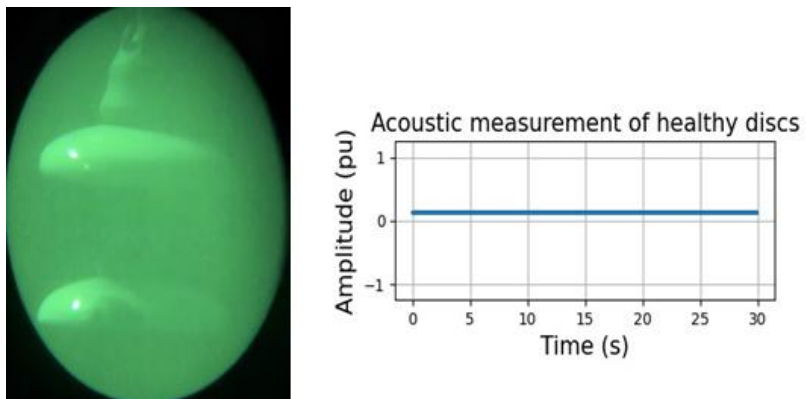
Figure 4.2 Image intensifier and acoustic measurements show no signs of surface discharge activities.

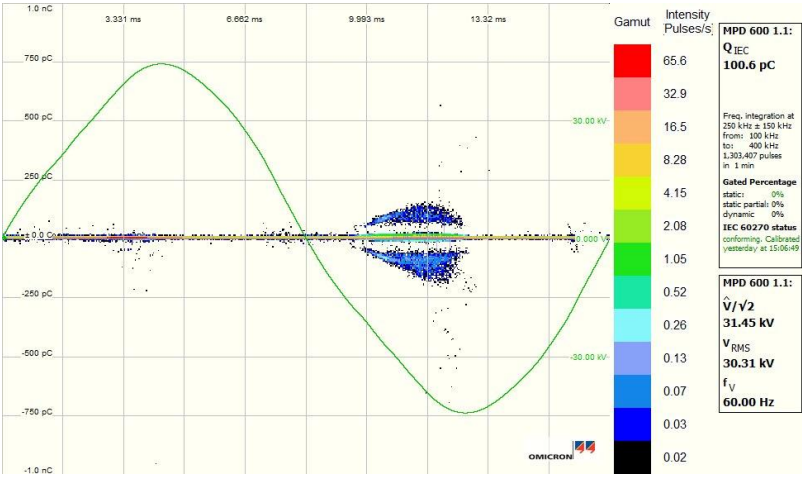
Figure 4.3 100 pC of surface discharges observed on the classical PD detector

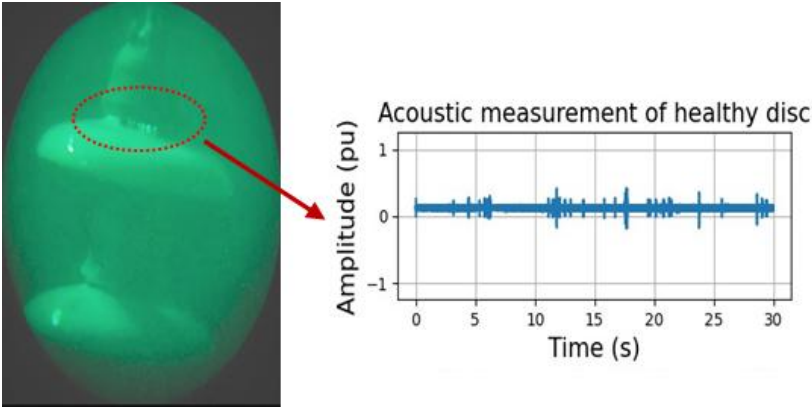
where the metallic cap, porcelain shell, and air meet. This observation was further confirmed using an image intensifier, as illustrated in Figure 4.4.

Figure 4.4 Surface discharges predominantly emanating from the healthy disc, as depicted in the image intensifier and acoustic measurement of the insulator string.

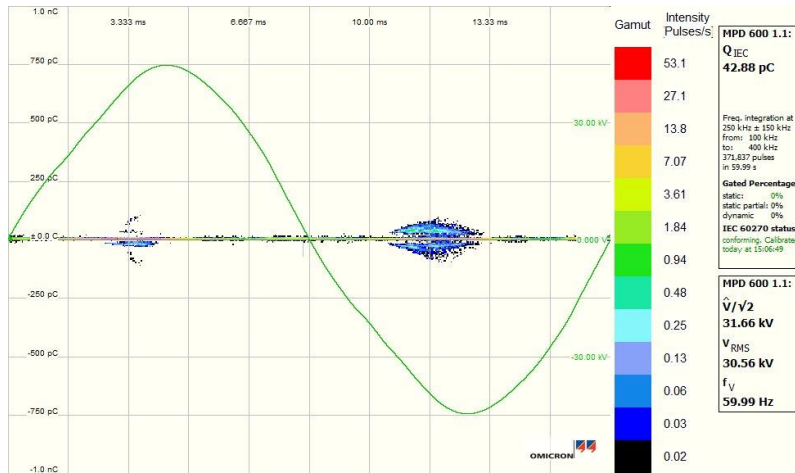
In the third configuration, the healthy insulator (#1) was positioned near the high-voltage side, while the defective insulator was located near the ground end. Although weaker PD activities were measured (approximately 50 pC), as shown in Figure 4.5, a consistent pattern emerged. Surface discharges persisted on the healthy insulator, as confirmed by acoustic measurements and image intensifier images, as illustrated in Figure 4.6.

Figure 4.5 Approximately 50 pC of surface discharges were observed on the classical PD detector.

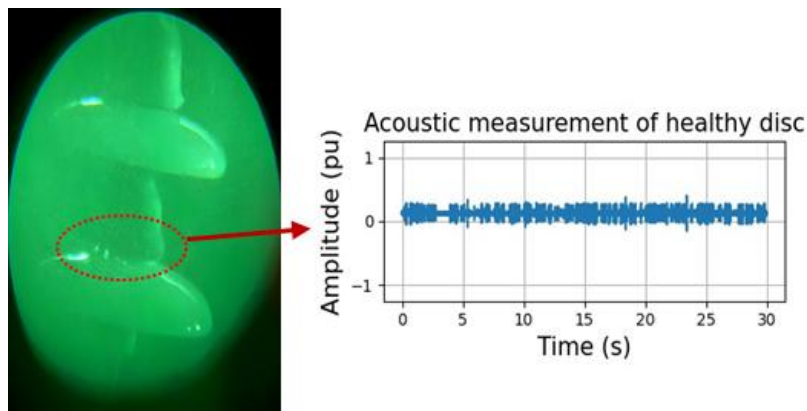
Figure 4.6 Surface discharges persisted on the healthy insulator, as depicted in the image intensifier and acoustic measurement of the insulator string.

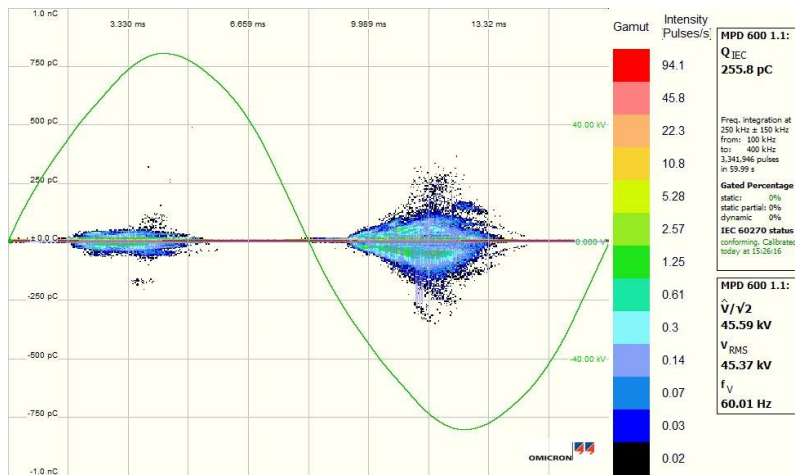
To further validate the observations, the experiment was conducted using all three discs listed in Table 3. The defective disc was positioned at the bottom of the string, near the high-voltage end, while the healthy discs were placed in the middle and at the top of the string, near the ground end. A voltage of 45 kV was applied to the string using a test transformer. Intense surface discharges, measuring 255 pC, were observed on both healthy discs, with no discharges detected on the defective insulator. PD activities and ultrasonic emissions originating from the triple-point interface of the healthy discs were detected through image intensifier and acoustic scans, as illustrated in Fig. 4.7 and 4.8, respectively.

Figure 4.7 Approximately 255 pC of surface discharges were observed on the classical PD detector.

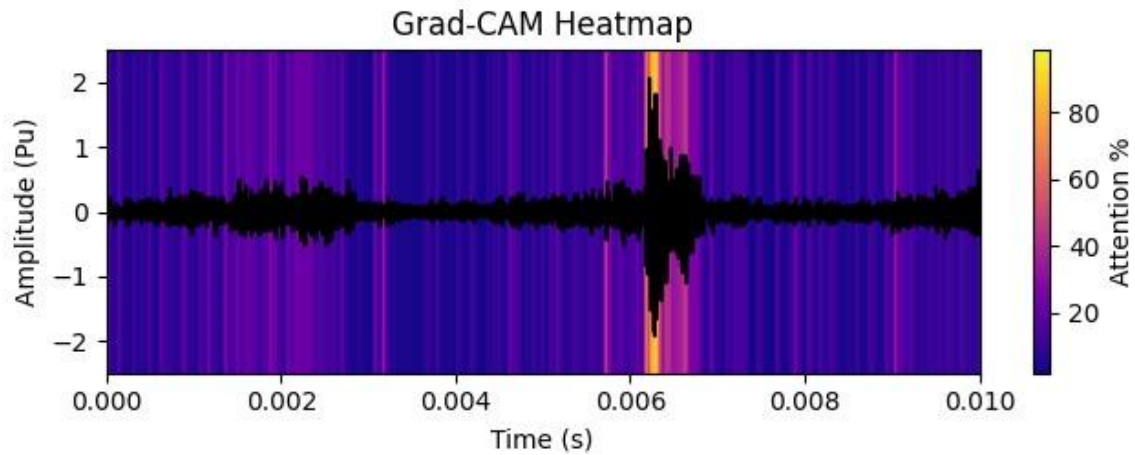
Grad-CAM visualizations provide valuable insights into the classification model's decision-making process by identifying regions of the ultrasonic signal that significantly influence its predictions. As shown in Figure 4.11, the heat map reveals that the model distinctly focuses on the initial high-frequency oscillations in the DBA ultrasonic signal captured from the LBS (15m away) before the signal undergoes damping. This indicates that the model relies heavily on these features for accurate classification.

Figure 4.11 Grad-CAM heatmap of DBA signal on the LBS (15m away)

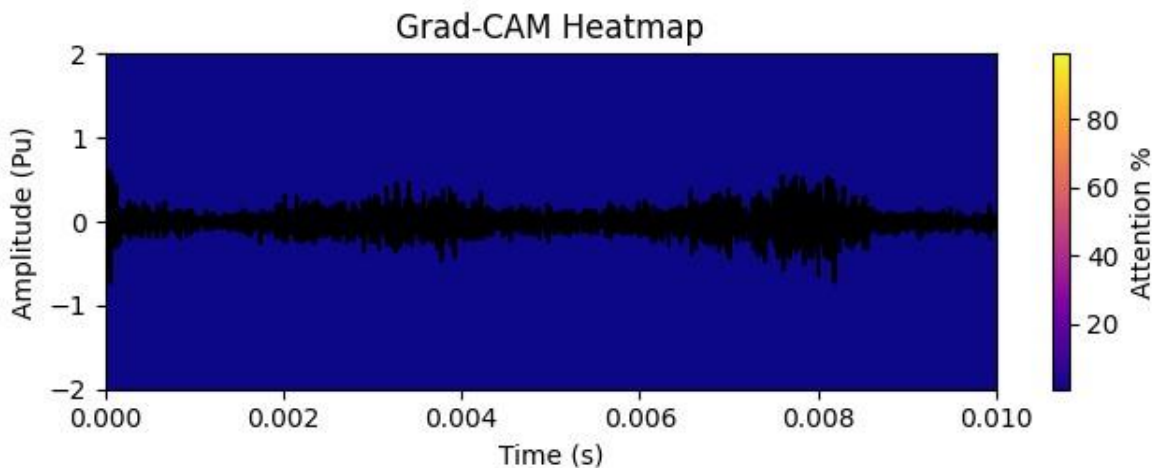
In contrast, misclassified signals, such as those from the cap-pin insulator, illustrate the challenges in identifying critical features over larger distances. For instance, Figure 4.12 demonstrates the application of Grad-CAM to a misclassified sample featuring an attenuated DBA signal from the cap-pin insulator (located 25m away). This visualization shows that the model struggled to focus on specific segments of the signal, highlighting its difficulty in handling attenuated features. These results emphasize the model's sensitivity to signal attenuation and the importance of maintaining signal clarity for accurate classification.

Figure 4.12 Grad-CAM heatmap of a misclassified DBA signal on the cap-pin insulator (25m away)

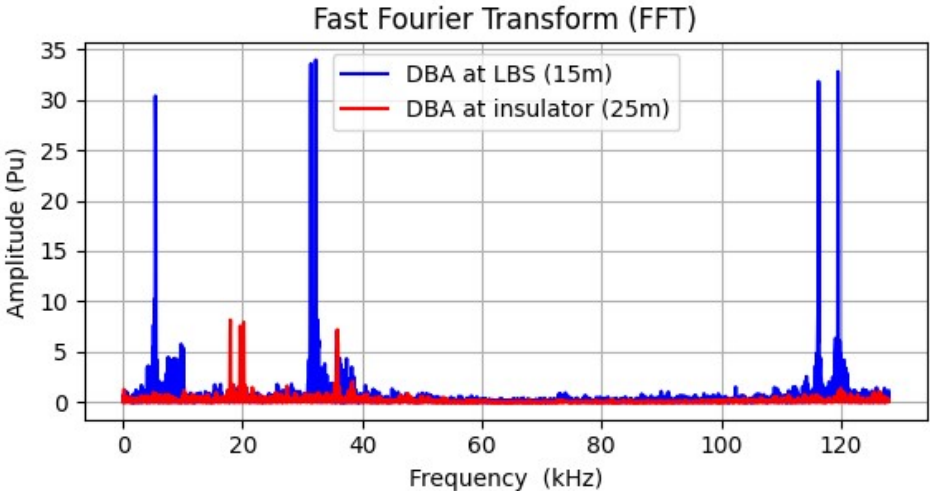
Figure 4.13 FFT of the accurately classified vs misclassified DBA signal at the LBS and cap-pin insulator.

In summary, this analysis underscores the intricate relationship between signal properties, propagation dynamics, and model interpretability. By integrating Grad-CAM visualizations with FFT analysis, it becomes evident that the attenuation of high-frequency features results in substantial feature loss, which directly affects the classification accuracy. These findings highlight the critical need for signal enhancement techniques to mitigate attenuation effects and enhance model performance in real-world scenarios.

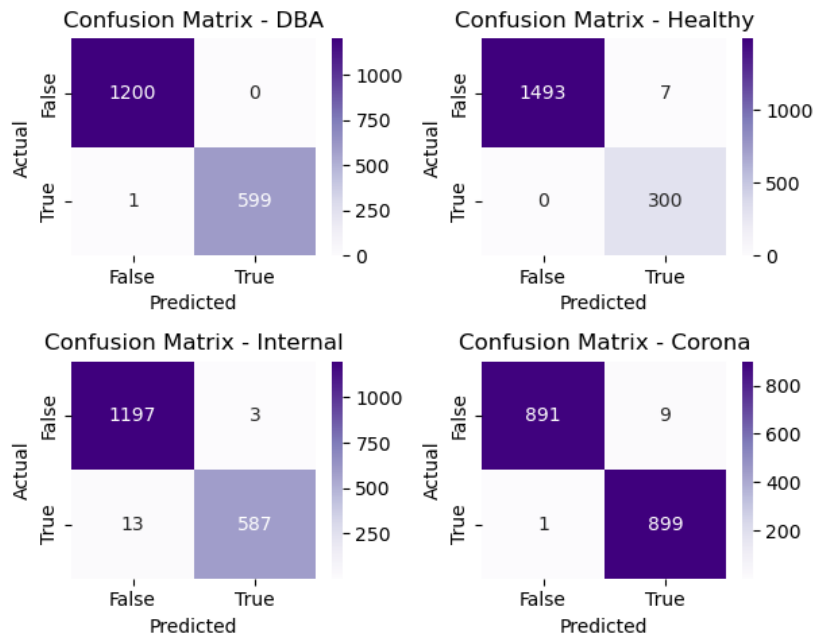
Figure 4.14 Confusion matrices for the 20% test split of combined dataset 1 and 2 (Overall Hamming score 98.4%)

In summary, the classification model consistently achieves excellent results across all datasets. While minor misclassification patterns are observed, particularly in the corona defect class, the overall performance demonstrates the model's capability to handle diverse scenarios effectively. Future efforts will focus on optimizing the model to further improve its generalization and accuracy.

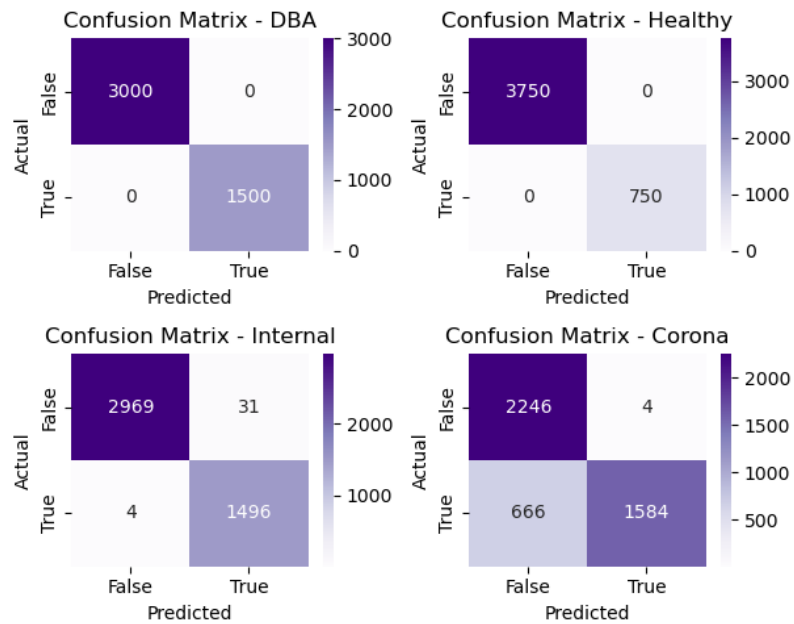
Figure 4.15 Confusion matrices on dataset 3 (Overall Hamming score 92%)

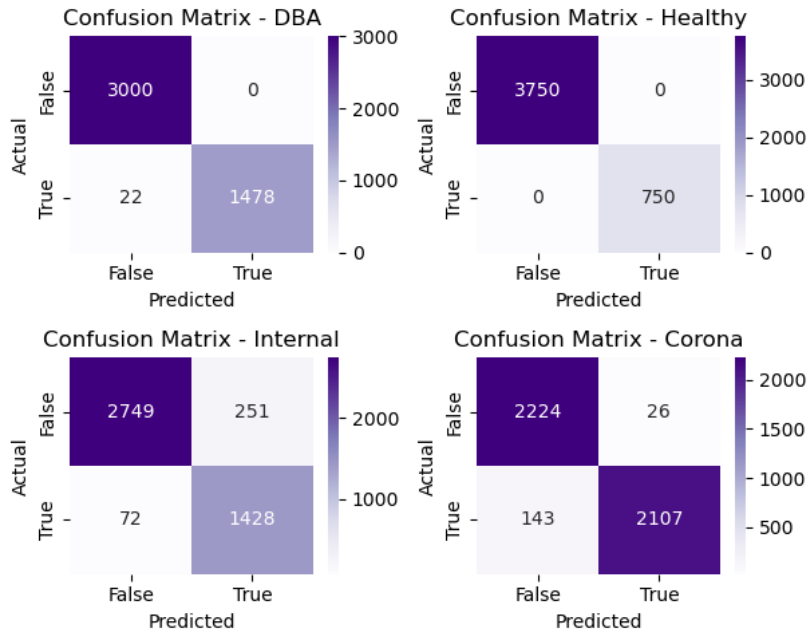
Figure 4.16 Confusion matrices on dataset 4 (Overall Hamming score 93.2%)

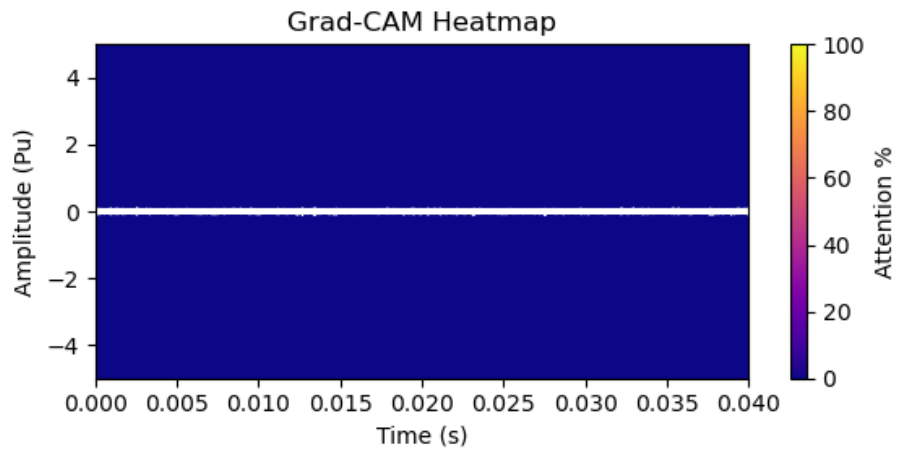
For defect-related classes, the model’s attention is predominantly concentrated on these features, whereas for the healthy class, the Grad-CAM results reveal an absence of prominent focal points. This lack of focus can be attributed to the noise-dominated nature of the healthy signals, which lack distinct characteristics necessary for effective classification.

Figure 4.17 Grad-CAM heatmap of healthy insulator signal

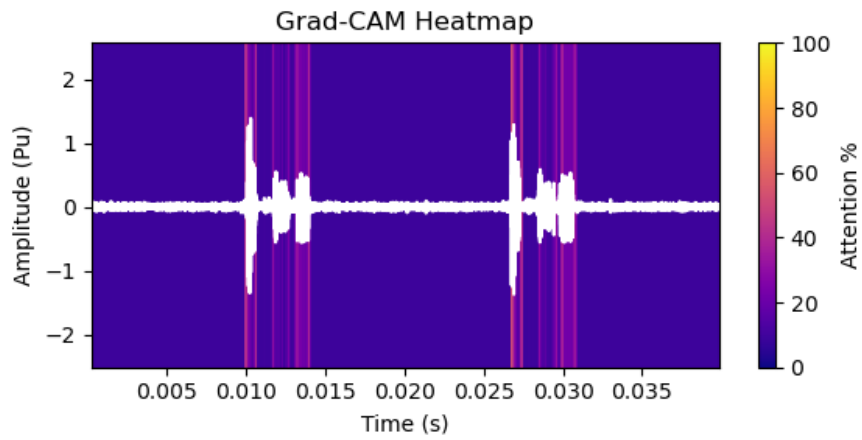
Figure 4.18 Grad-CAM heatmap of Corona signal

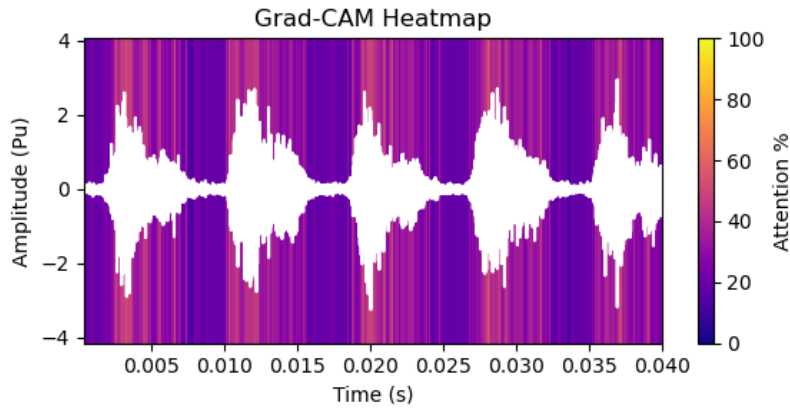
Figure 4.19 Grad-CAM heatmap of DBA signal

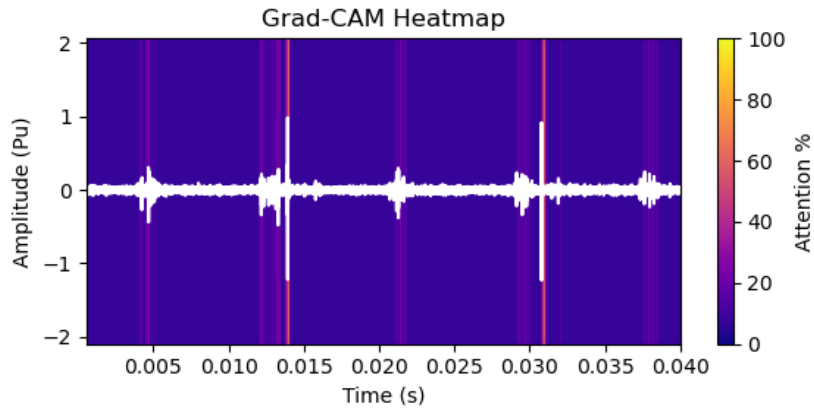
Figure 4.20 Grad-CAM heatmap of Punctured Insulator signal

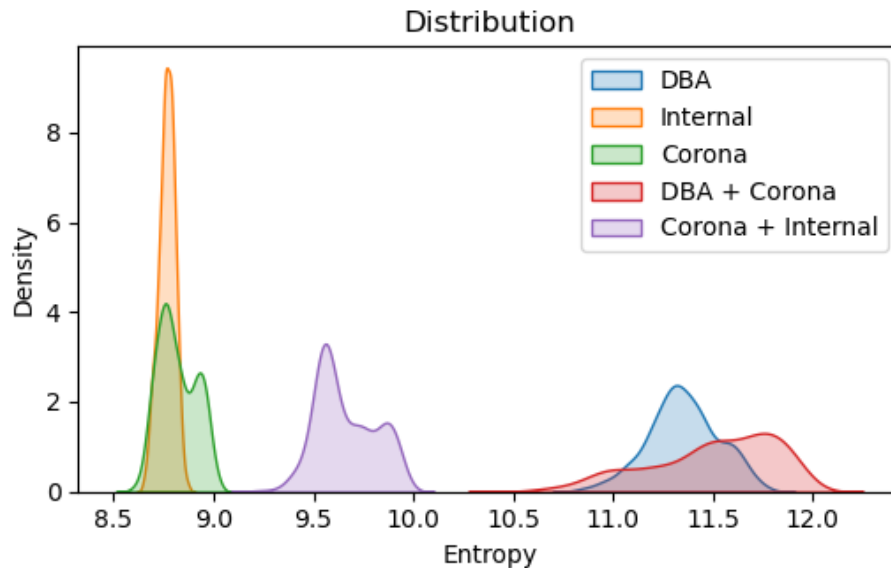
However, the entropy profiles of the corona and internal defect classes exhibit a notable similarity, which can be attributed to the interaction between punctured insulators and neighboring healthy insulators. These interactions give rise to surface discharge activities, a form of PD that closely aligns with the characteristics of corona discharge [60]. Furthermore, the DBA and (DBA + Corona) classes display overlapping entropy patterns, reflecting their shared defect type, DBA. This overlap may explain the model's challenges in distinguishing isolated corona discharge events from those that occur alongside internal defects or DBA.

Figure 4.21 KDE plot representing the distribution of Shannon entropy across 3,650 ultrasonic signals of all defect types

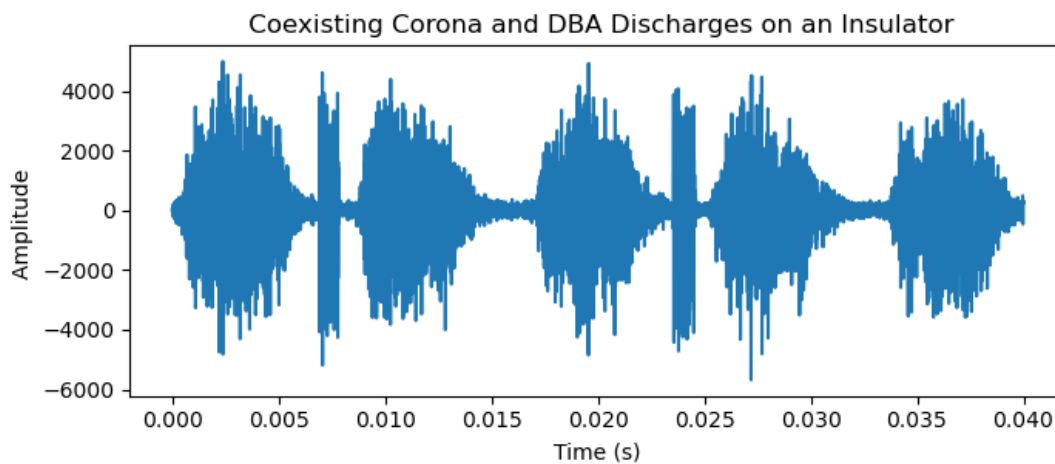
Figure 4.22 illustrates this phenomenon, presenting a sample ultrasonic signal that captures the simultaneous occurrence of DBA and corona discharges on an insulator. This nuanced understanding of temporal features, combined with entropy-based insights, provides a comprehensive framework for defect classification, emphasizing the interplay between transient and temporal domains in identifying complex defect scenarios

Figure 4.22 Ultrasonic signal showing both DBA and corona on an insulator string
